Maryland-Delaware-District of Columbia Water Science Center
Seminar Series

**Geomorphic Responses to Stream Channel Restoration at
Minebank Run, Baltimore County, Maryland**

**Ed Doheny, Hydrologist/Surface-Water Specialist
U.S. Geological Survey, MD-DE-DC Water Science Center**

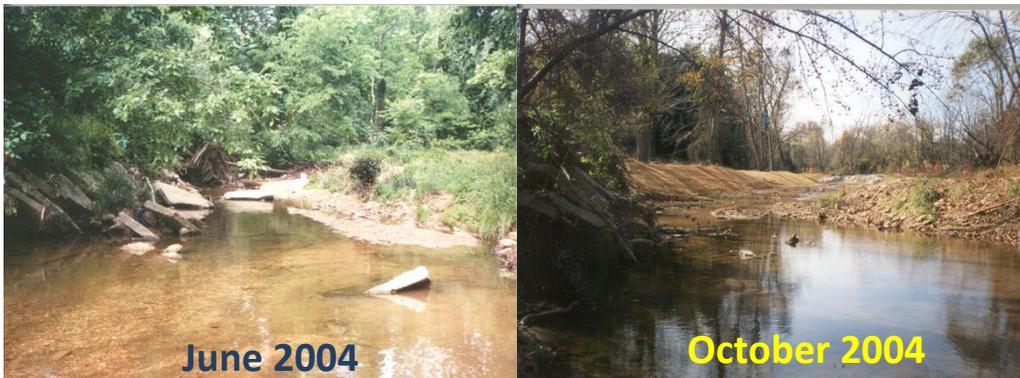
**Minebank Run at
USGS streamgage
in Cromwell Valley
Park, Baltimore
County, Maryland
before and after
restoration.**

The pre-restoration dimension, pattern, profile, and composition of the stream channel at Minebank Run were quantified, and changes over time caused by storms and flooding were assessed. Changes in cross-sectional area, bed elevation, lateral migration of the stream channel, rate of bank retreat, and grain-size distribution were measured throughout the study reach. Similar post-restoration characterizations of the dimension, pattern, profile, and composition of the stream channel were done and compared to the pre-restoration conditions to assess the natural response to stream channel restoration. Much of the post-restoration geomorphic variability that was observed was primarily due to alternating patterns of sediment storage and removal, and shifting of the channel thalweg, in contrast to channel degradation and widening, and lateral erosion from receding cut banks observed during the pre-restoration monitoring.
